Fact Sheet for Skagit Plastics Debris Pile Cleanup (McGlinn Island causeway)

Background:

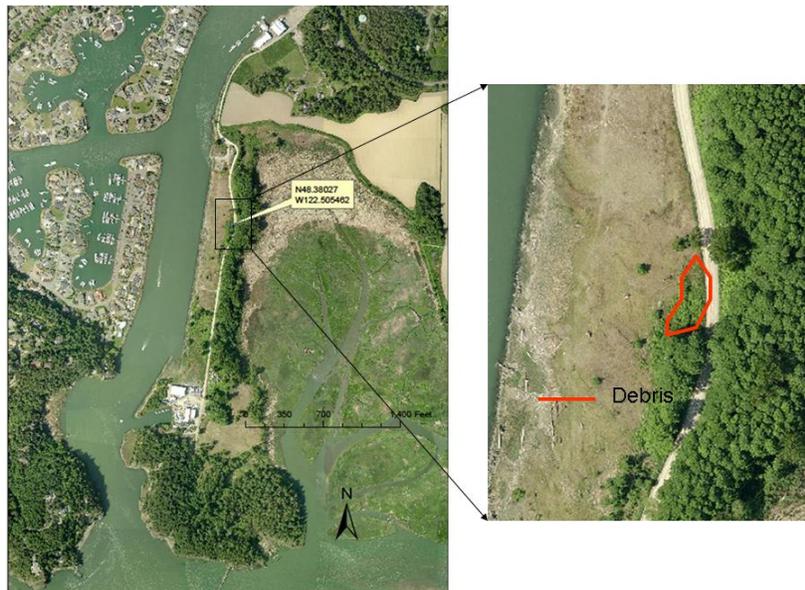
This site is located south of the town of La Conner, in the northern portion of the causeway connecting McGlinn Island to the mainland. The site was previously discovered and investigated in a Brownfields Phase II environmental site assessment of McGlinn Island and causeway. This location, along with most of McGlinn Island and its causeway, became Swinomish tribal trust land in 1993, as a result of a quiet title action by the U.S. government, and after many years of contested ownership between the Tribe and non-Indian owners. It appeared that a substantial amount of burned and unburned fiberglass material and other debris, likely resulting from a mid-1980s fire that destroyed the Skagit Plastics composite boat factory at the north end of the causeway, was deposited at this location, and then partially buried under dredge spoils from the Swinomish Channel (Fig. 1).

Figure 1. Skagit Plastics Debris Pile on McGlinn Island causeway.

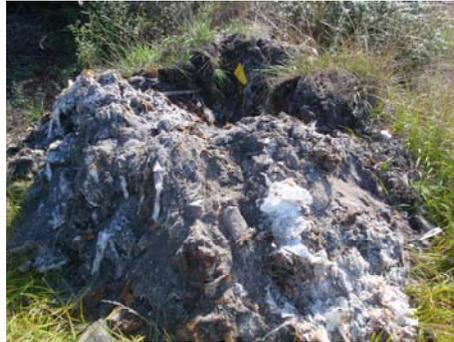
When the weeds and brush covering the pile were removed, it became evident that the pile contained a well mixed combination of debris and soil of the same nature as the tested samples (Fig. 2). It is not yet determined

Figure 2. Partially excavated debris from the Skagit Plastics debris site.

whether dredge spoils beneath the pile may have been contaminated by leachate from the debris over the last 30 years. The Phase II report discussed several cleanup alternatives for this location, but given the future planned use of the area (part of a salmonid habitat restoration project), the only reasonable alternative, from the Tribe's perspective, involved the excavation and disposal of the contaminated material in the pile, as well as any contaminated soils beneath it.

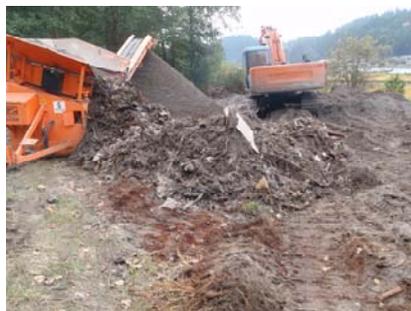
The large amount of debris overlaying the area made it difficult to determine the extent of soil contamination beneath the pile and therefore the ultimate cleanup requirements. Funds from the 2010 Swinomish Brownfields Tribal Response Program were used in September and October 2010 to conduct a partial cleanup of the site. Although the material contained contaminants above ARARs unrestricted use cleanup levels, leaching tests revealed the debris was not required to be regulated as hazardous waste, and therefore could be disposed of in the sub-title D landfill used by Skagit County for municipal waste. A local contractor removed and disposed of over 400 cubic yards of the debris/soil mixture, with a total weight of over 230 tons. The remaining material at the site, several hundred tons of sand mixed with smaller pieces of fiberglass and other waste, was screened to remove as much debris as possible (Fig. 3). The screened sand currently remains on site.

Figure 3. Screening debris from the soil.

Using 2011 Brownfields Tribal Response Program funds, the Tribe plans to characterize the contamination present in the dredge spoils beneath the removed debris, to determine if further cleanup actions are required. A December 2010 lab analysis of soil samples from the screened sand piles indicated remaining contamination (from the previously detected analytes of concern) was below the cleanup levels being used for the site; therefore the screened material may not require removal. If further excavation and disposal of soils at the site proves to be necessary, additional funds will have to be procured to complete the cleanup.
