Subj: Due diligence re the disposal of the Skagit Plastics debris pile refuse located on the McGlinn Island causeway (Swinomish Reservation, La Conner, WA).

**2008 Brownfields Phase II Environmental Site Assessment
Screening Results from the Skagit Plastics Debris Pile,**

**2010 TCLP Testing Results from the Skagit Plastics Debris Pile,
(McGlenn Island Causeway, Swinomish Reservation, La Conner, WA)**

RE: Skagit Plastics Dump Pile

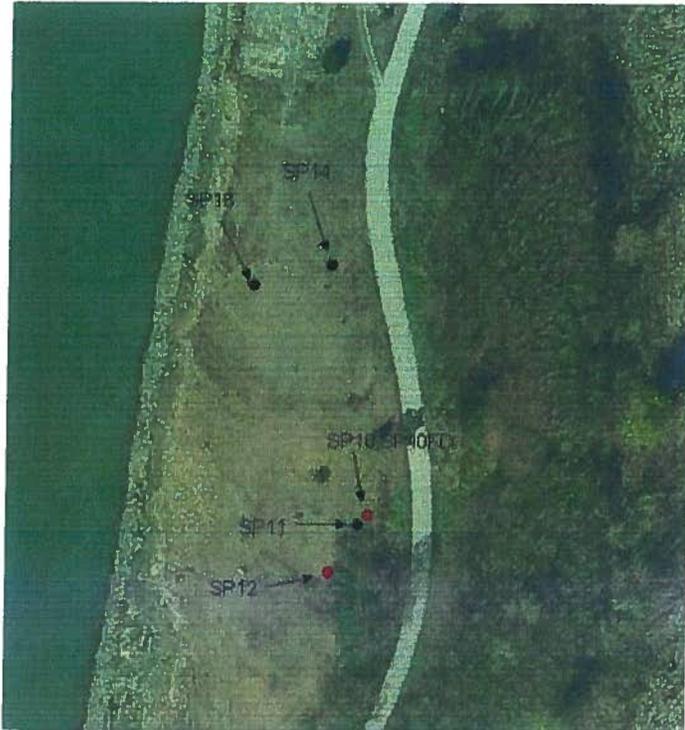
Figure 3-4 Skagit Plastics Area Sampling Locations – McGlinn Island

On October 30, 2008, five soil samples were collected from the Skagit Plastics Debris Area. Figure 3-4 shows the locations of samples SP10 through SP14. Samples SP10 through SP12 were collected from the perimeter of a partially buried debris pile along McGlinn Island Lane. Samples SP13 and SP14 were collected near the Reservation boundary. All five samples were submitted to Fremont Analytical to be analyzed for SVOCs and TAL metals and to Pace Analytical for dioxin/furan analysis. Samples SP10 through SP12 also were submitted for asbestos analysis at Fremont Analytical.
