Subj: Fact Sheet for Skagit Plastics Debris Pile Cleanup (McGlinn Island causeway)

Background:

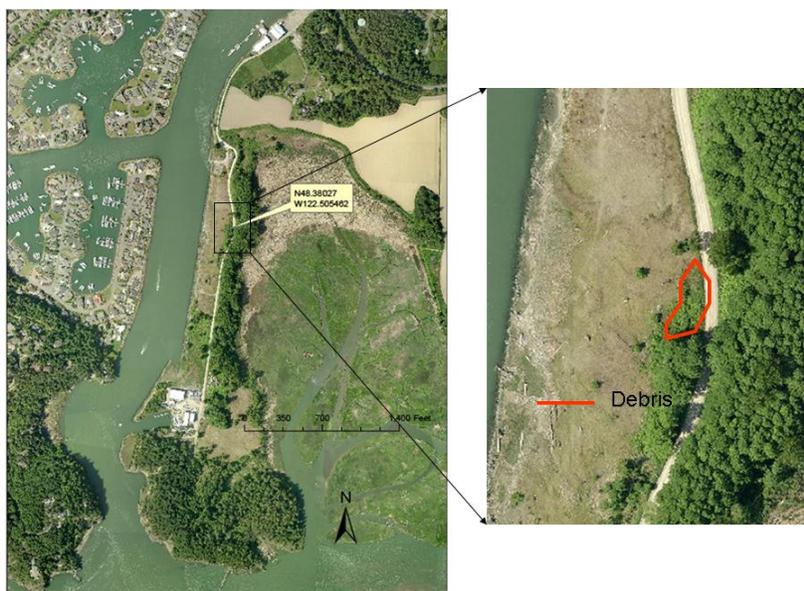
This site is located south of the town of La Conner, in the northern portion of the causeway connecting McGlinn Island to the mainland. The site was previously discovered and investigated in a Brownfields Phase II environmental site assessment of McGlinn Island and causeway. This location, along with most of McGlinn Island and its causeway, became Swinomish tribal trust land in 1993, as a result of a quiet title action by the U.S. government, and after many years of contested ownership between the Tribe and non-Indian owners. It appeared that a substantial amount of burned and unburned fiberglass material, likely remaining from the mid-1980s fire that destroyed the Skagit Plastics composite boat factory at the north end of the causeway, was deposited at this location, and then partially buried under dredge spoils from the Swinomish Channel (Fig. 1).

Figure 1. Skagit Plastics Debris Pile on McGlinn Island causeway.

During the years since the dumping ended, mineral soils and organic detritus combined with the material, resulting in a problematic mix of uncontaminated and contaminated debris and a contaminated soil/debris matrix. During the Phase II assessment, the larger area of the pile could not be tested because it was overgrown with blackberries and other vegetation. However, samples taken from the edges of the pile were of a soil/debris matrix containing large amount of visible charred material and burned fiberglass strands. Several of these samples revealed metals and dioxin contamination above Washington Model Toxics Control Act (MTCA) soil cleanup levels for unrestricted use. No petroleum was present and no samples contained asbestos. When weeds and brush covering the pile were removed, it became evident that the pile contained a well mixed combination of debris and soil of the same nature as the tested samples (Fig. 2). It is not yet determined whether dredge spoils beneath the pile may have been contaminated by leachate from the debris over the last 30 years. The Phase II report discussed several cleanup alternatives for this location, but given the future planned use of the

area (part of a salmonid habitat restoration project), the only reasonable alternative, from the Tribe's perspective, involved the excavation and disposal of the contaminated material in the pile, as well as any contaminated soils beneath it.

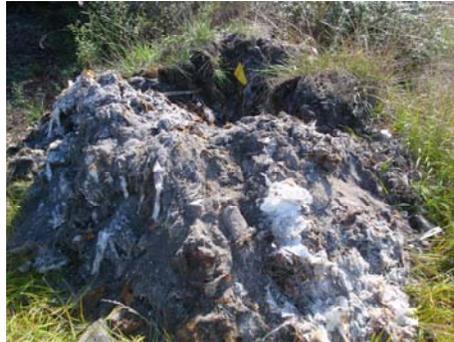
Figure 2. Partially excavated debris from the Skagit Plastics debris site.

The large amount of debris overlaying the area made it difficult to determine the extent of soil contamination beneath the pile and therefore the ultimate cleanup requirements. Funds from the 2010 Swinomish Brownfields Tribal Response Program were used in September and October 2010 to conduct a partial cleanup of the site. Although the material contained contaminants above unrestricted use cleanup levels, leaching tests revealed the debris was not required to be regulated as hazardous waste, and therefore could be disposed of in the sub-title D landfill used by Skagit County for municipal waste. A local contractor removed and disposed of over 400 cubic yards of the debris/soil mixture, which had a total weight of over 230 tons. The remaining material at the site, several hundred tons of sand mixed with smaller pieces of fiberglass and other waste, was screened to remove as much debris as possible (Fig. 3). The screened sand from this last operation currently remains on site.

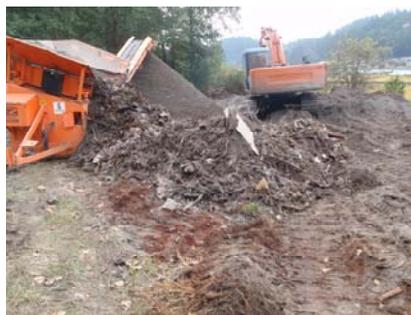
Figure 3. Screening debris from the soil.

Using 2011 Brownfields Tribal Response Program funds, the Tribe plans to characterize the contamination present in the dredge spoils beneath the removed pile to determine if further cleanup actions are required to bring soils at the site below MTCA levels for unrestricted land use. The piles of screened sand remaining on site will also be characterized for contamination levels, in order to determine whether they can be redistributed on site or must be removed. If off-site disposal of this material or further excavation of soil at the site proves to be necessary, additional funds will have to be procured to complete the cleanup.
